OPAL TOWER INVESTIGATION FINAL REPORT

**Independent Advice to
NSW Minister for Planning and Housing**

19 February 2019

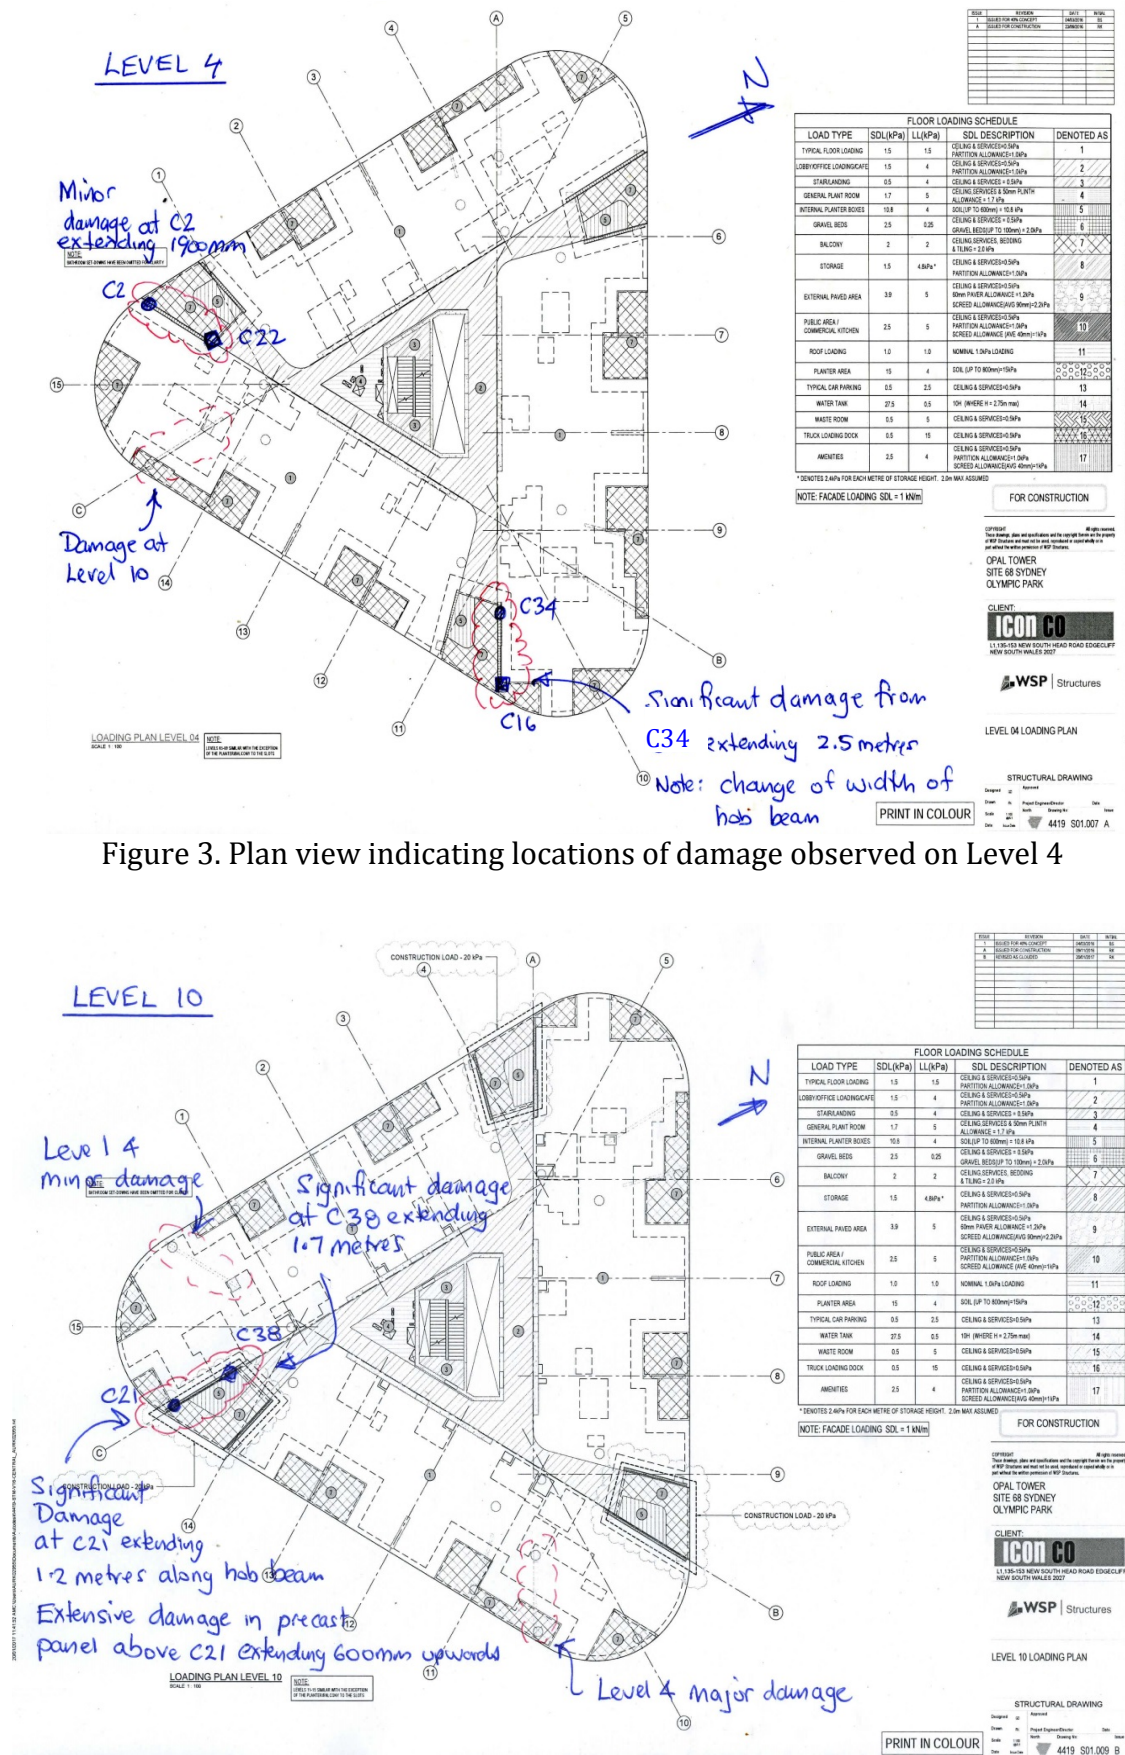
The areas of significant structural damage are located on Levels 4 and 10 of the Opal Tower. The approximate locations of these damaged regions are shown in Figures 3 and 4.

Figure 3. Plan view indicating locations of damage observed on Level 4

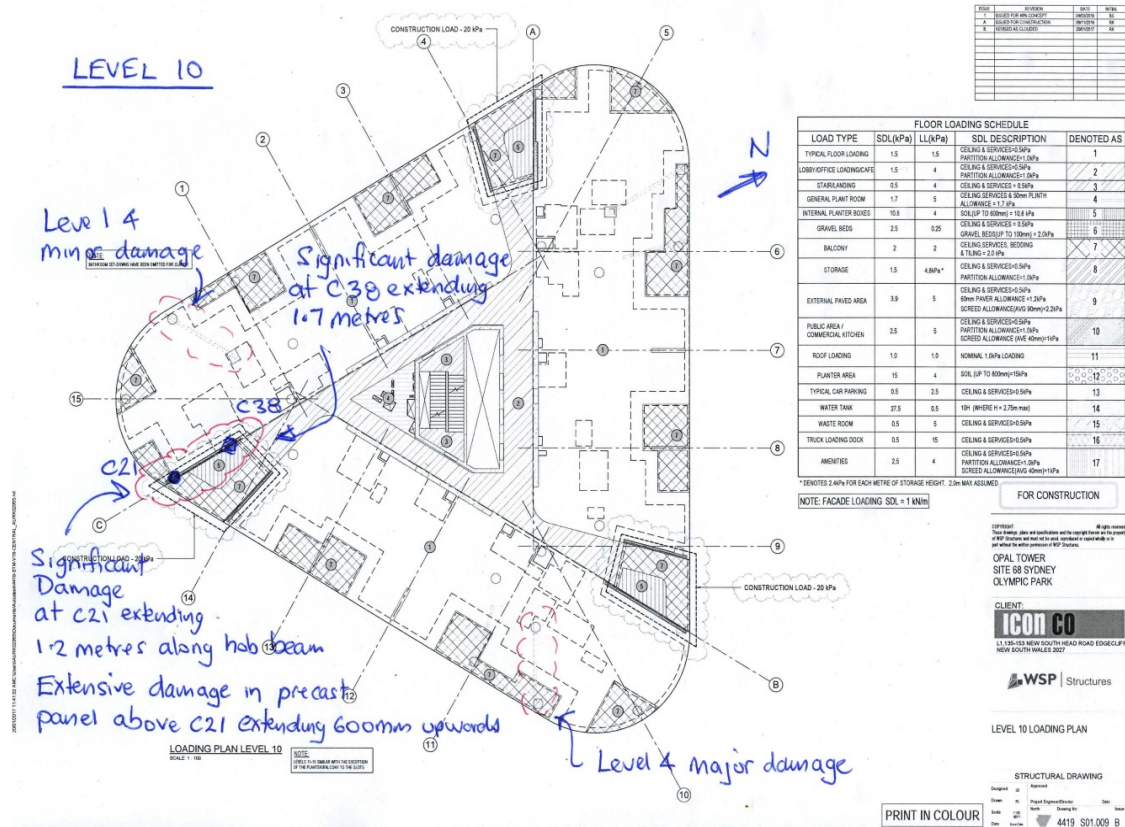
Figure 4. Plan view indicating locations of damage observed on Level 10

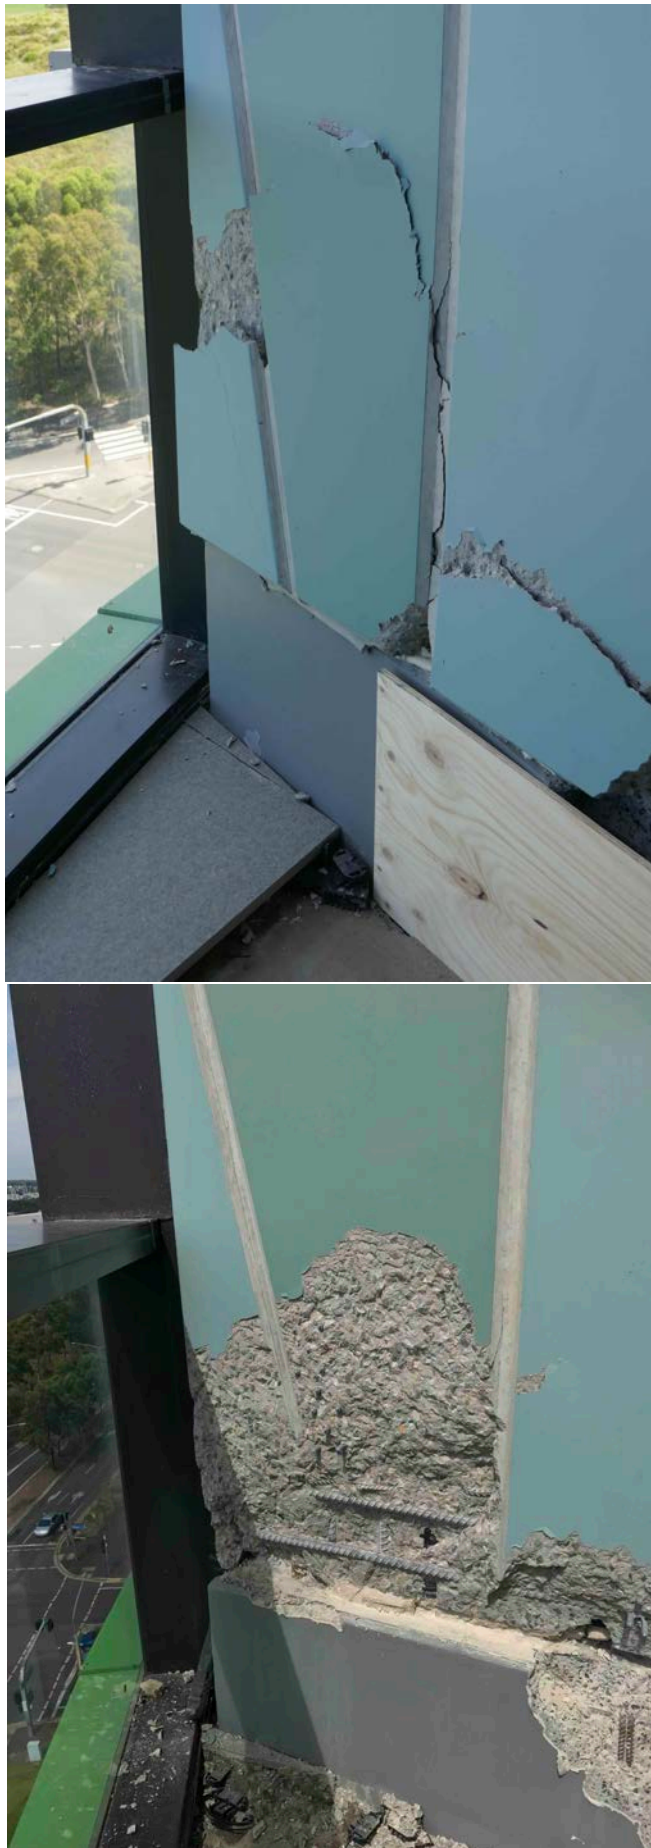
1. A hob beam spanning between columns C21 and C38 (along grid line C shown in Figure 4) and the Panel A resting on it – see Figures 5 to 8. Cracking was also observed in the floor plate adjacent to column C21 – see Figure 9. This was the damage observed on Christmas Eve and is considered to be major damage.

Figure 5. Damaged precast Panel A at Level 10 above column C21, before (top) and after (bottom) broken section of concrete removed.

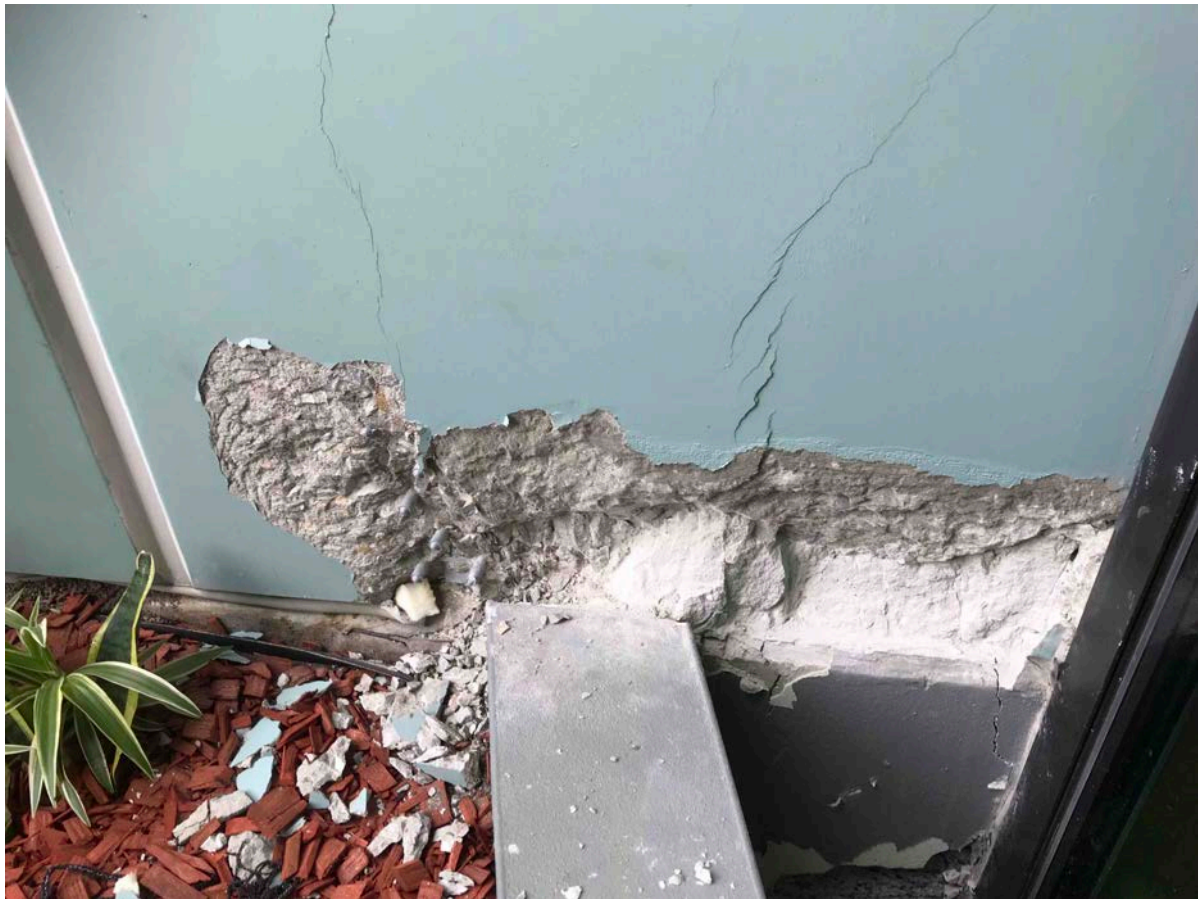
Figure 6. Damaged precast Panel A at Level 10 above column C38, after some broken sections of concrete removed.

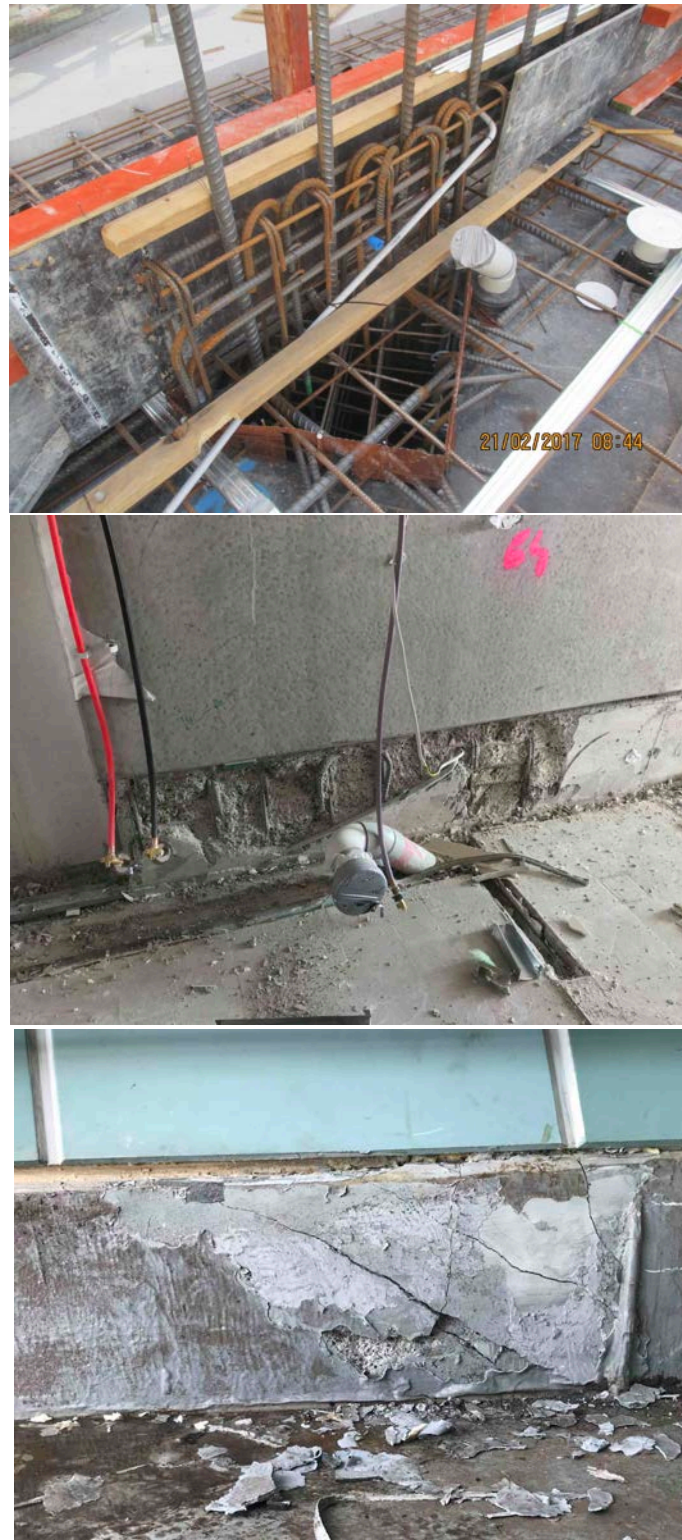
Figure 7. Photographs of the hob beam in the vicinity of column 38 at level 10, prior to pouring concrete (top photo), inside the building on 8 January 2019 after cracked concrete cover removed (middle), and outside on 8 January 2019 after the garden and waterproof covering removed (bottom). Note the positioning of the reinforcing bars, the encroachment of the column bars into the cover zone, the lack of anchorage of some horizontal bars, and the encroachment of a conduit into the concrete cover zone. The vertical dowel bars that engage with the precast concrete panels can also be seen in the top photograph.

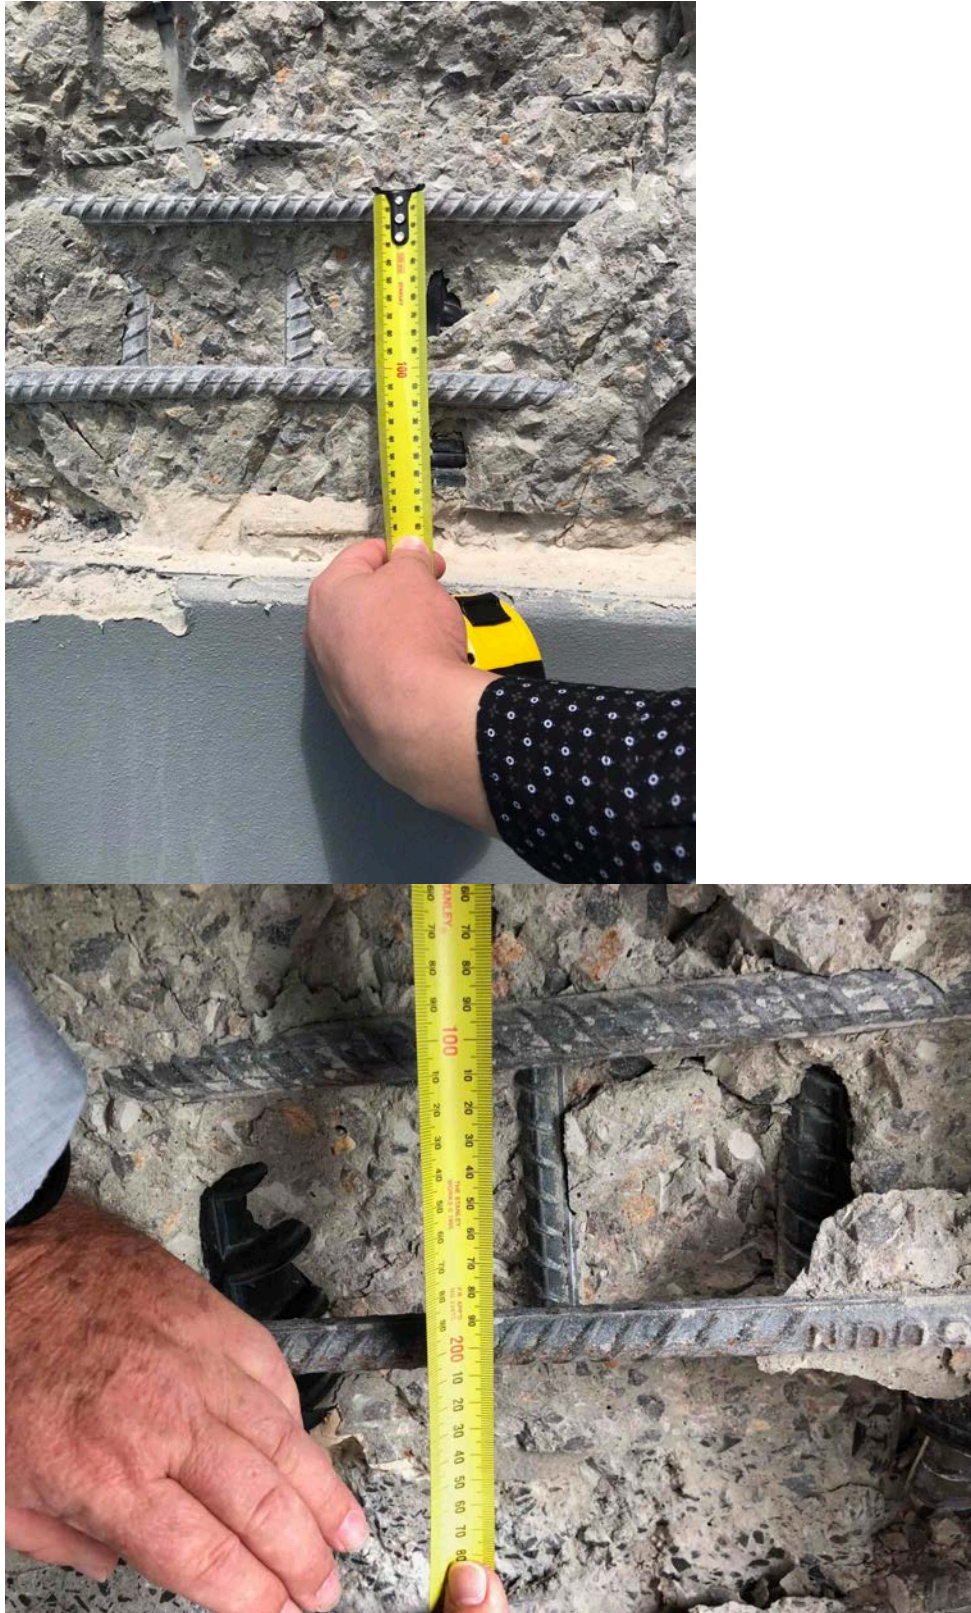
- (e) Potentially inadequate tensile capacity in the horizontal direction in the bottom region of Panel A on that rests on the hob beam spanning columns C21 and C38 on Level 10. There is compelling evidence indicating that the wrong size reinforcing bars were placed in this area during manufacture of this particular

Figure 8. Photographs of the outside (top) and inside (bottom) of panel A at Level 10 just above hob beam adjacent to column 21, indicating N20 reinforcing bars at 100 mm centres in the lower portion of the precast panel. Note the exposed grout between panel A and the hob beam and the black plastic sheath for the joining dowel (top photo, right of tape measure).

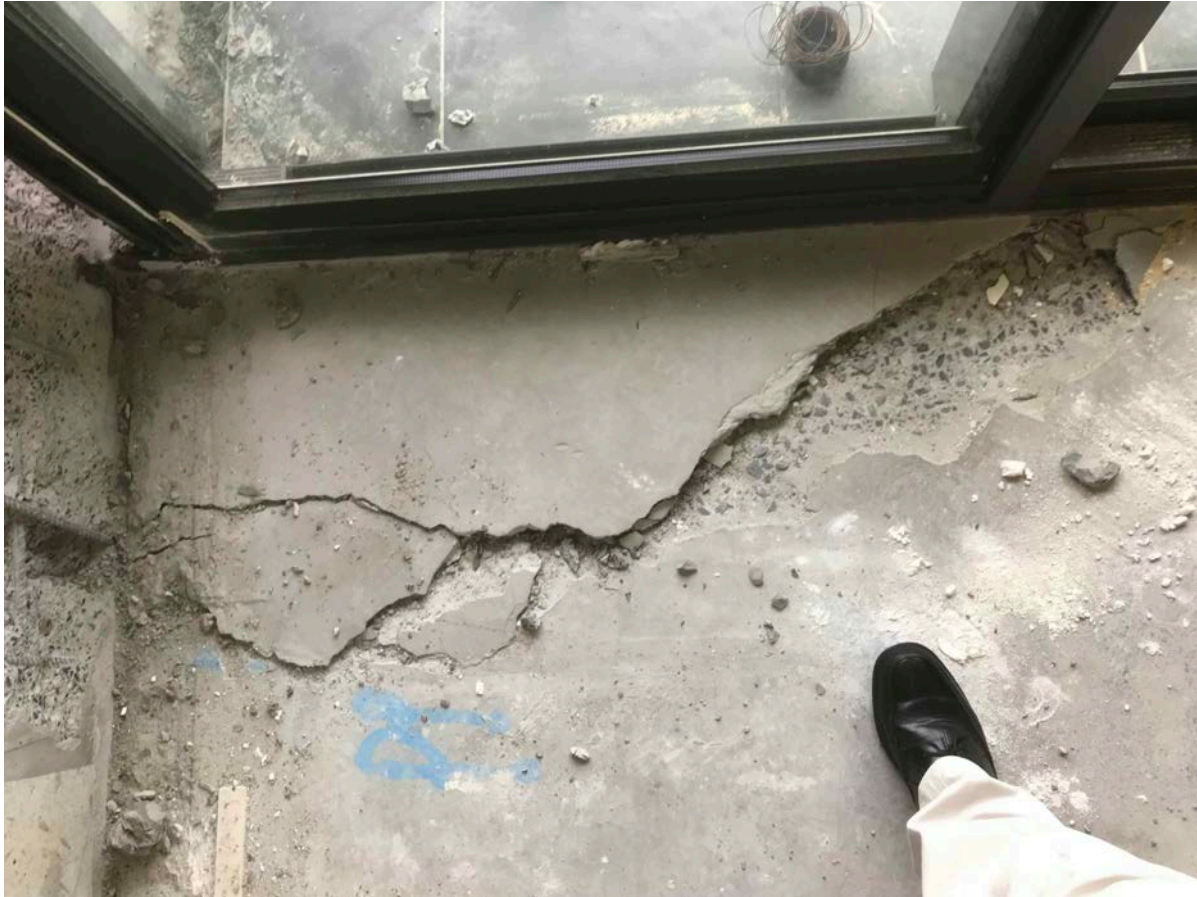
4. The observed damage in the concrete panel at Level 10 and in the Level 10 floor slab was likely a consequence of the adjacent hob beam failures and not the original cause of the damage observed at Level 10.

Figure 9. Photographs of the damaged floor slab adjacent to column C21 on Level 10.

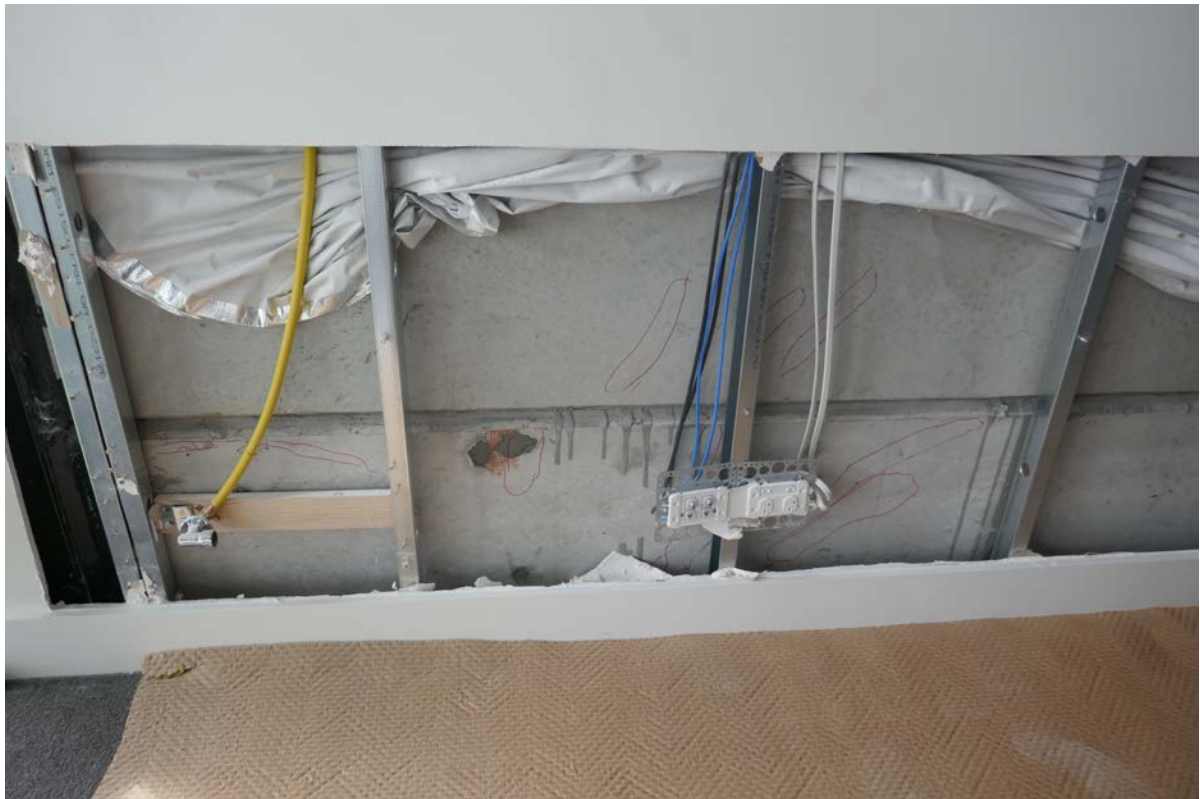
Figure 11. Photograph of the hob beam and panel on Level 4 near column C2 with red lines indicating minor cracking.

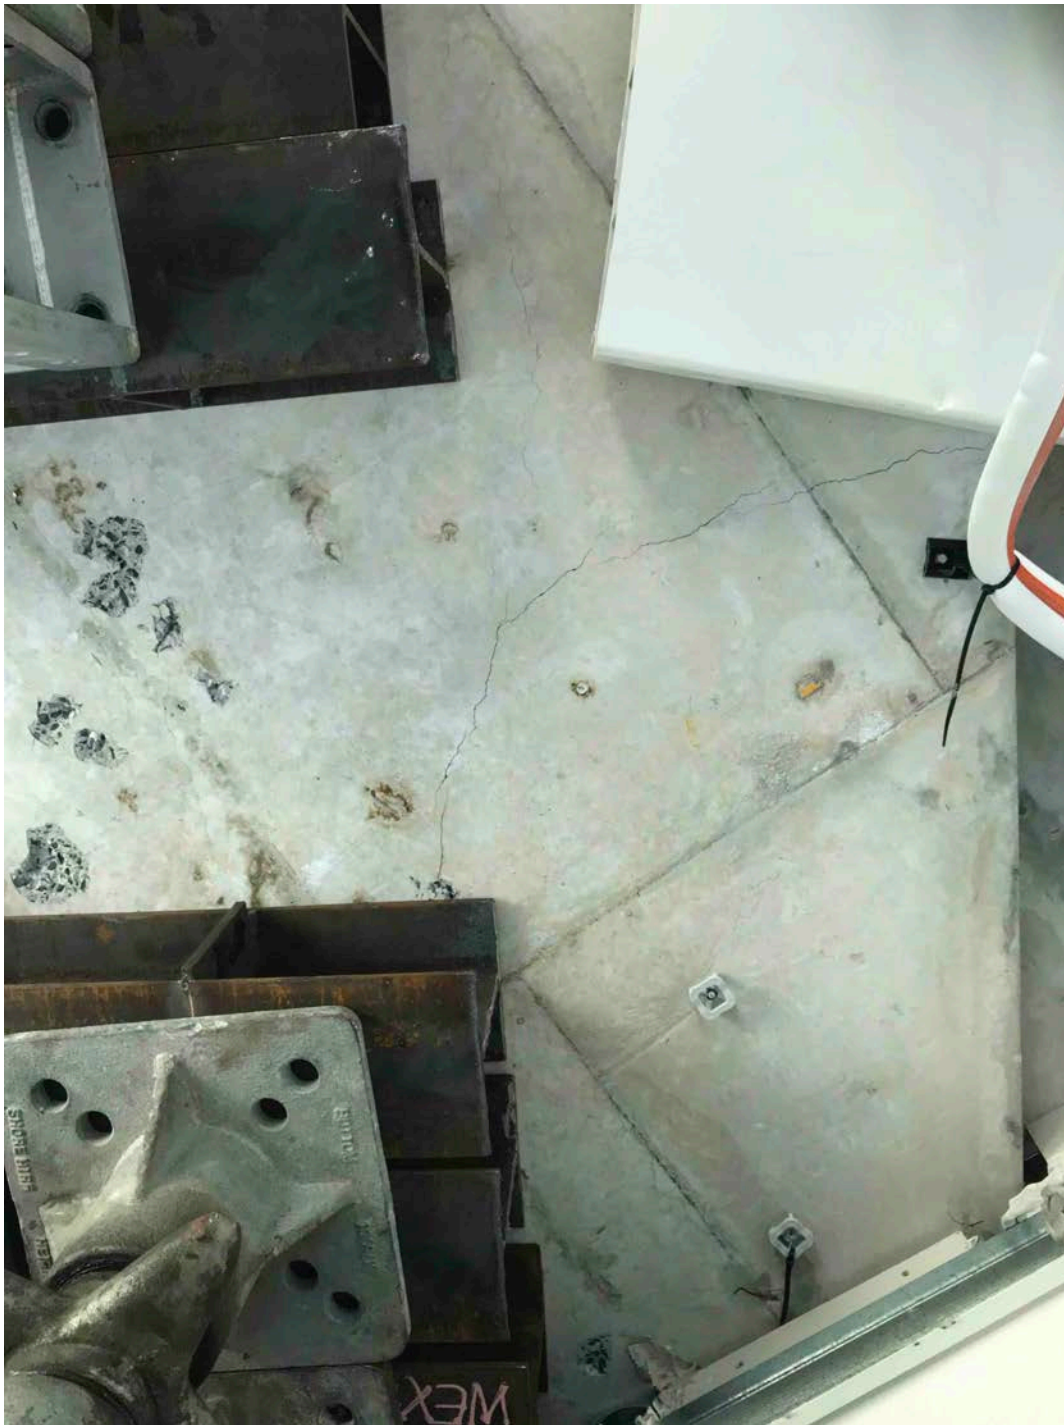
2. A hob beam spanning between columns C16 and C34 (along grid line A shown in Figure 3) – see Figure 10. This also appears to be major damage.
3. A hob beam spanning between columns C2 and C22 (along grid line B shown in Figure 3). These cracks could be considered minor *at this stage* – see Figure 11.
4. Cracking was also observed in the floor plate between Levels 3 and 4 – see Figure 12. This was considered to be major damage.

Figure 12. Photograph of a crack in the floor plate between Levels 3 and 4.

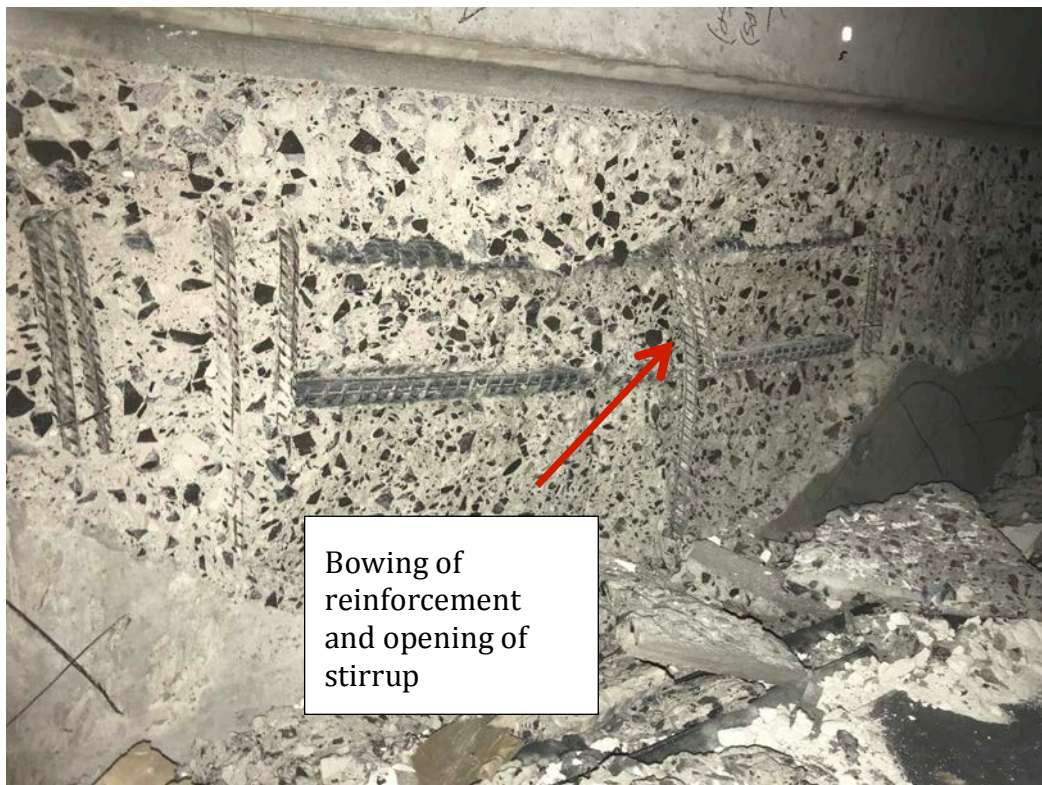
The damage observed in the hob beam above Column C34 at Level 4 is shown in Figure 15. This image indicates bowing of the reinforcement steel outwards from the beam and opening of the stirrup. Also noticeable is a lack of cross-tie reinforcement to guard against splitting failure..

The site observations of the damaged beam are consistent with a bursting failure.

Figure 15. Damage in hob beam at Level 4 above column C34 showing bowing of reinforcement and opening of stirrup.

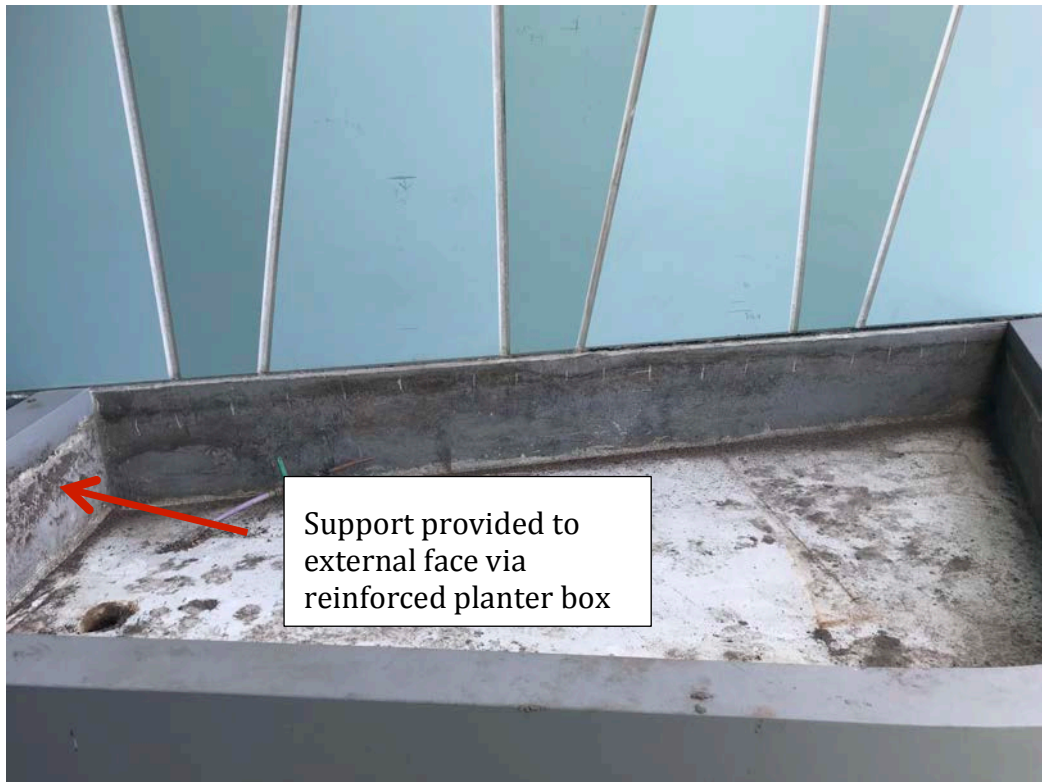
It is notable that the observed damage was constrained to the inside facing of the hob beam; the outside of the hob beam at the critical section was supported by a lateral garden bed wall (Figure 16) built integrally with the slab and against the hob beam. This wall likely provided support to the outer side of the hob beam forcing the damage inward where such support was lacking. This damage remained “hidden” until exposed on 27 December 2018 after removal of an internal wall in the adjacent apartment. It is not known when this damage occurred.

Figure 16. Lateral support provided to hob-beams at outside elevation through reinforced planter box hob – Level 4 Grid Line A.

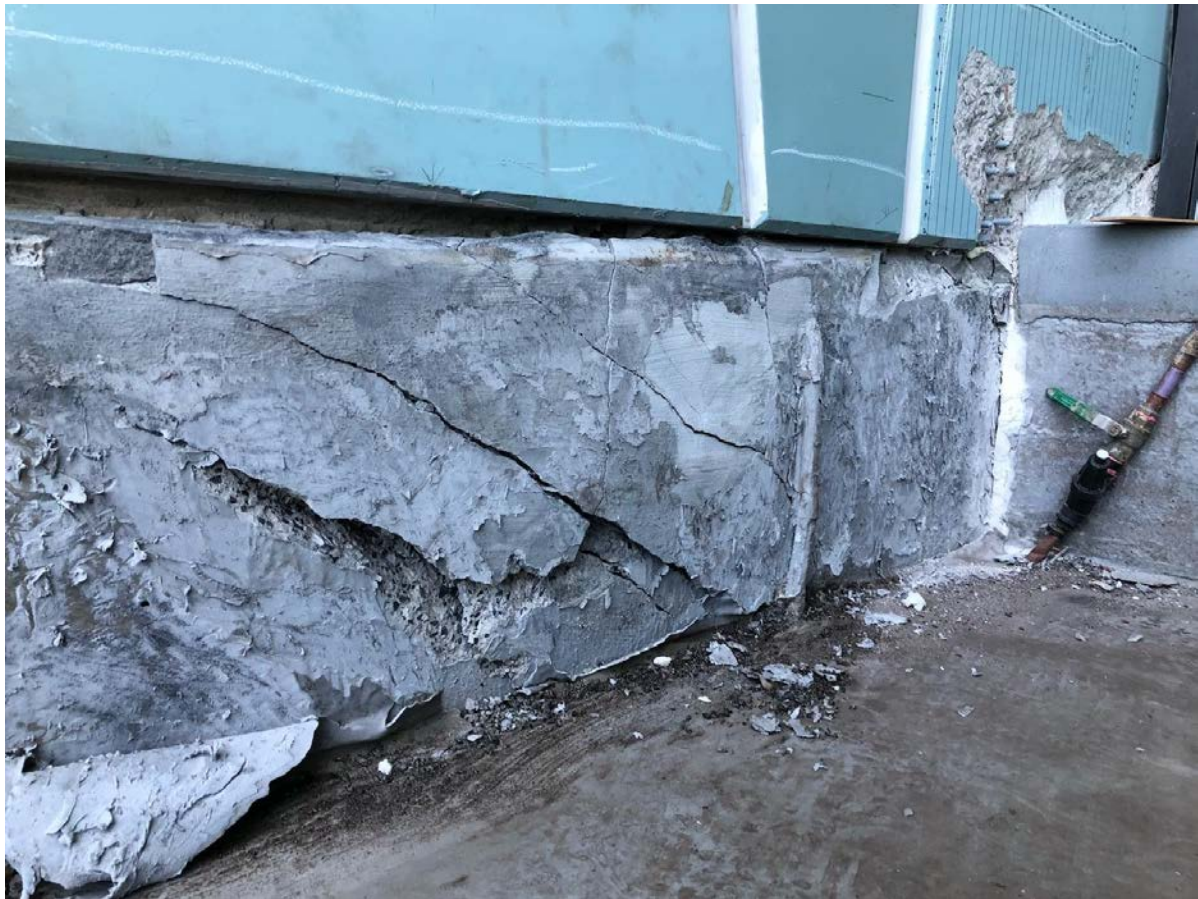
The damage in the hob-beam above Columns C21 and 38 at Level 10 is shown in Figures 17 to 20. For the hob-beam above column C38, Figure 17 shows splitting along the lines of shear compression, indicating high levels of stress on each of the in-plane and out-of-plane surfaces. While bursting appears to be the dominant mode of failure, bearing stresses appear to have also been influential in forming the failure surfaces.

Figure 17. Hob beam at Level 10 in the vicinity of column C34 (outside) showing splitting along shear compression crack band lines.

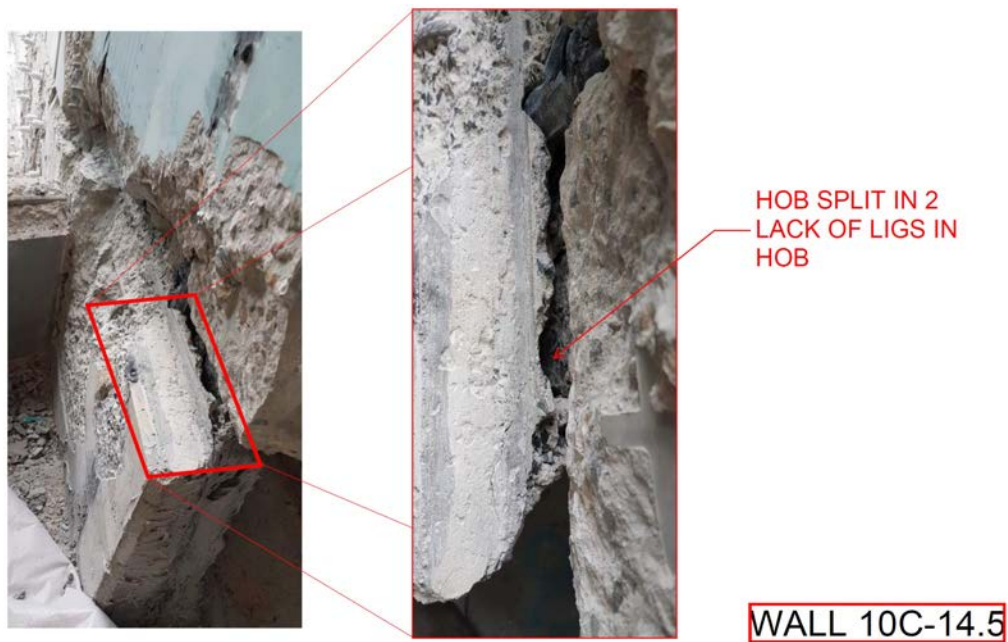
OVERVIEW OF HOB SPLIT

Figure 18 shows observations presented to us of the hob beam above Column C38 when the walling was opened. These images reveal evidence of splitting along the hob centreline. A crack, running the length of the hob beam between the supporting columns, was also observed at the soffit of the Level 10 floor slab (Figure 19). Splitting of the hob and wall panel is also evident in Figure 20.

Figure 18. Photographs at Wall 10C-14.5 (Level 10 grid line C) documenting a splitting crack in the hob beam.

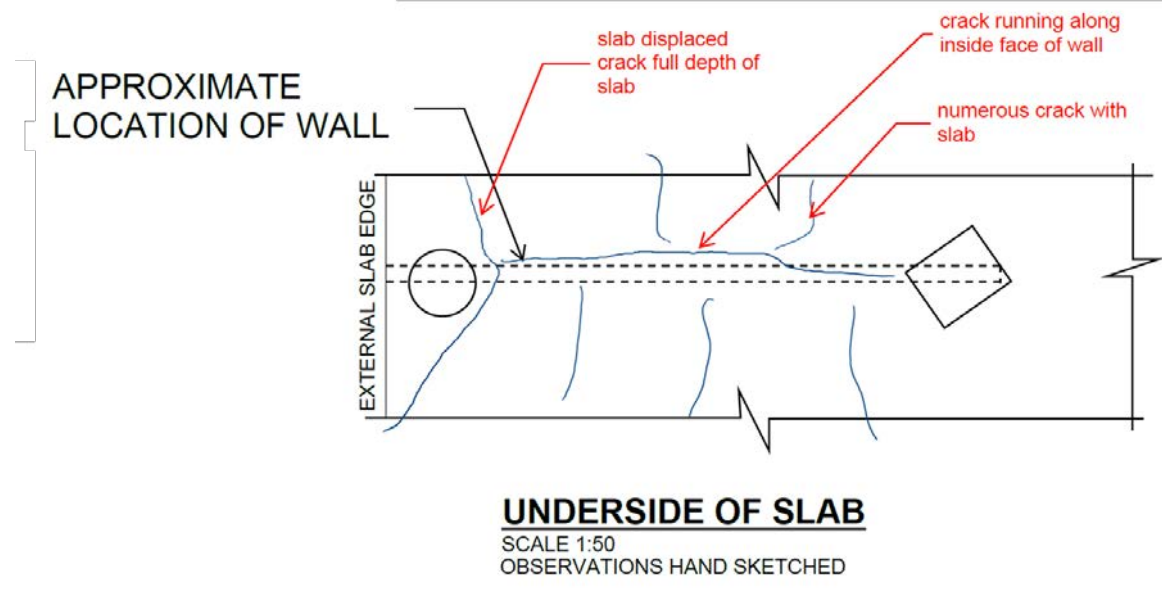
Figure 19. Drawing of the underside of Wall 10C-14.5 (Level 10 grid line C) documenting a splitting crack in the floor slab between columns C21 and at C38.

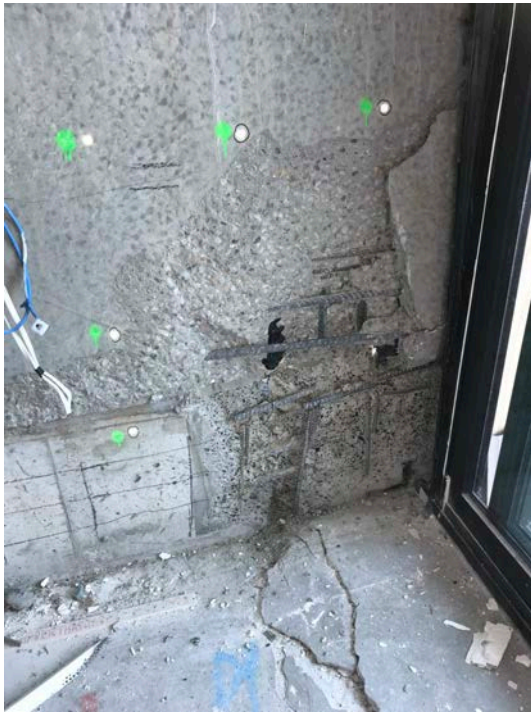
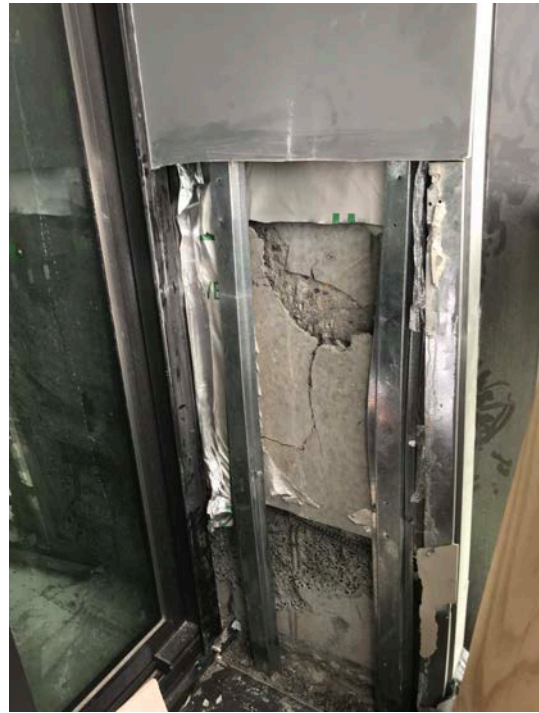
These observations are consistent with our calculations that indicate a lack of capacity of the hob against bursting. As for Level 4, no cross-tie reinforcement is evident in the hob-beam at either location where spalling or crushing occurred.

Figure 20. Hob-beam and precast wall panel at Level 10 in the vicinity of column C21 (apartment side) showing splitting of the precast panel and the damaged hob beam.
