OPAL TOWER INVESTIGATION FINAL REPORT

**Independent Advice to
NSW Minister for Planning and Housing**

19 February 2019

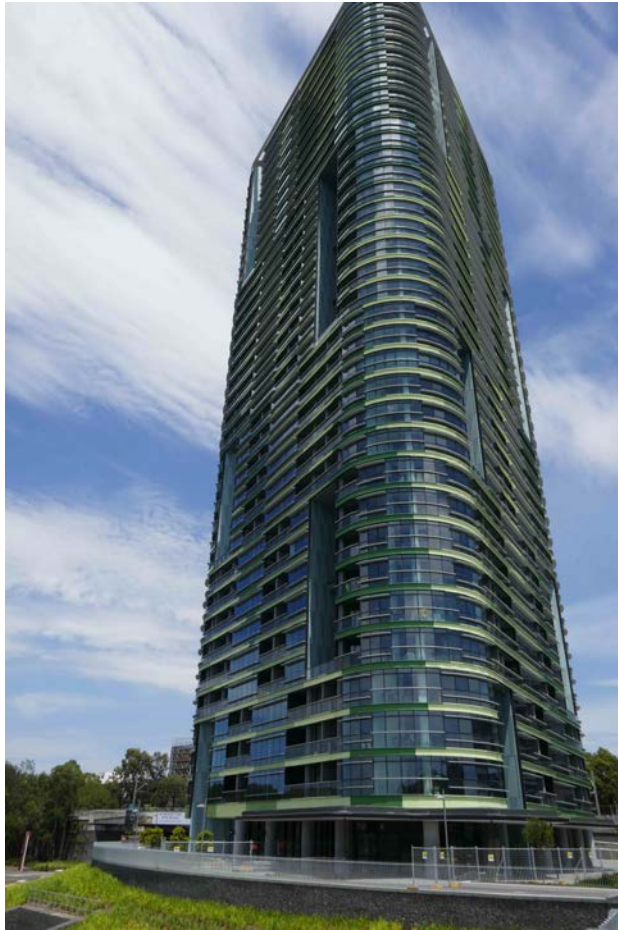
A photograph of the Opal Tower is shown in Figure 1. The building is characterised by its overall triangular prismatic shape, with a number of insets in the three external faces of the building (see Figures 1 and 2). These architectural features are referred to as “slots” on some design drawings.

Figure 1. General view of the Opal Tower. Note the inset slots on the external faces of the building, each extending for multiple storeys (some 6 and others 10 storeys).

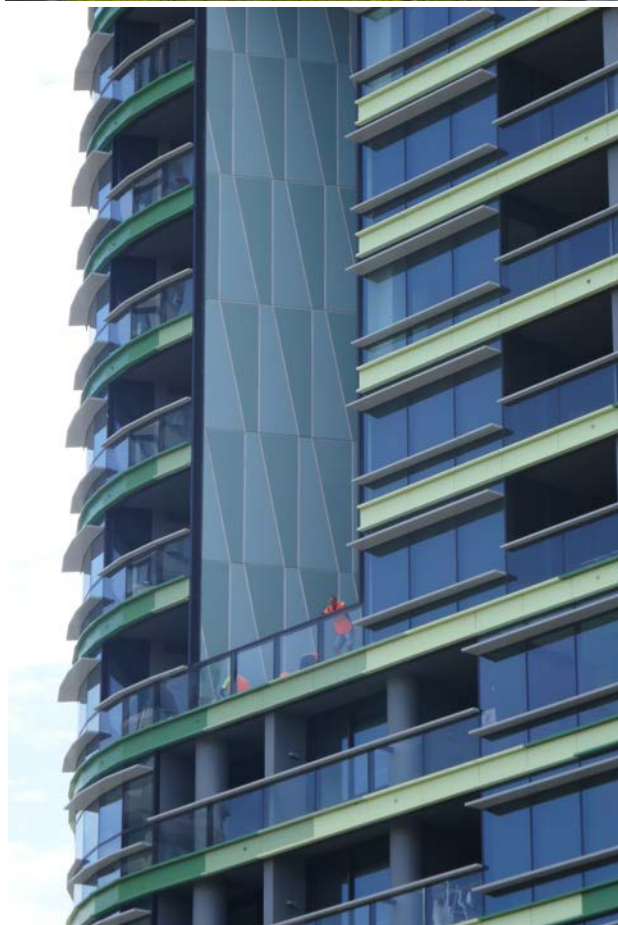
Figure 2. Close-up view of a 6 storey slot. Note the 6 panels forming the load bearing wall of the inset slot, each one storey high.

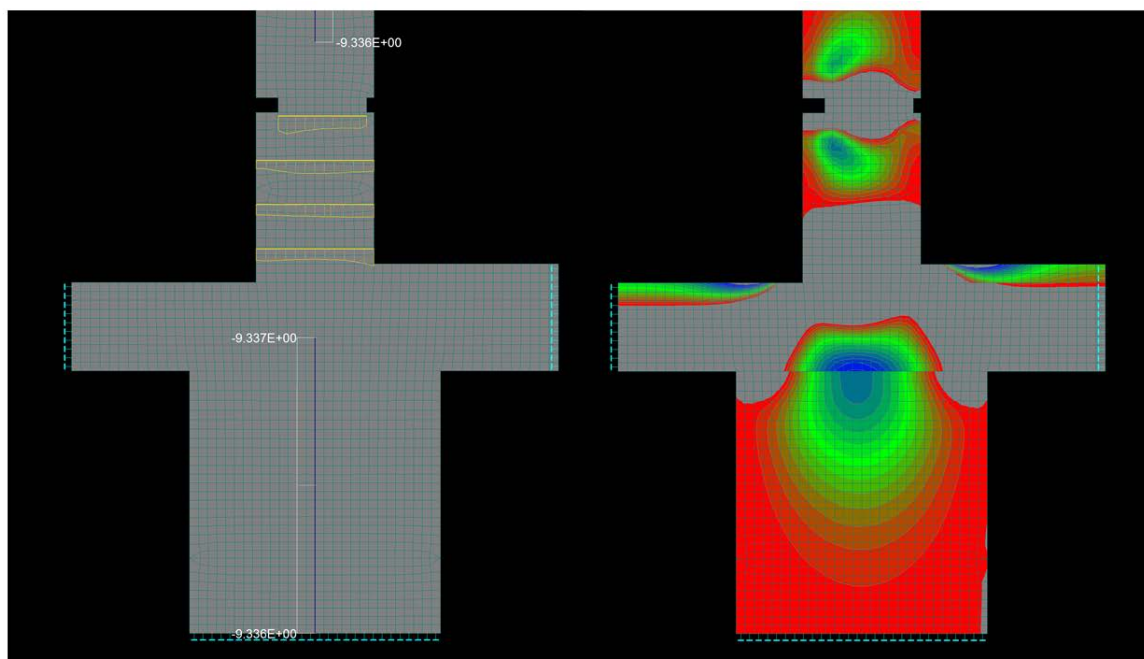
The finite element analysis (Figure 13), albeit preliminary, indicated significant splitting forces in the column adjacent to the hob beam. It would be prudent to undertake a more detailed analysis of this feature and to confirm if appropriate bursting reinforcement is in place. Rectification works may be necessary pending the outcome of the abovementioned detailed analysis.

Figure 13. Typical distributions of axial stresses acting on the hob-beam (left) and tensile bursting stresses (right) – Level 4 Grid Line A.

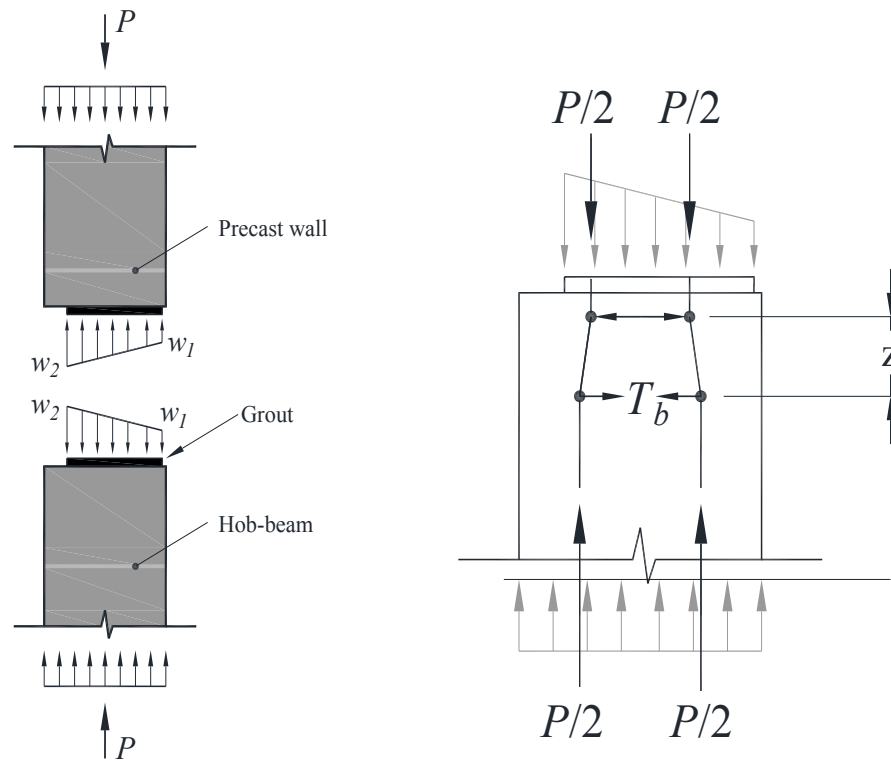
The hand calculations considered the capability of the hob in both bearing and bursting. The axial forces passing through the pre-cast wall panel to the hob beam connection, and then into the columns, were addressed. Some of these calculations adopted the ‘strut and tie model’ describing equilibrium of forces in the hob beam (Figure 14). This hand calculation method followed the approach specified in AS3600.

Figure 14. Schematic representation of axial forces and stresses passing through the wall panel to hob-beam grouted connection (left), and strut-and-tie model describing bursting forces that result from the disturbance caused by the joint's geometry (right).
